Gigacycle fatigue initiation mechanism in Armco iron

Chen Wang, D. Wagner, Q. Y. Wang, C. Bathias

Chen Wang, D. Wagner, Q. Y. Wang, C. Bathias. Gigacycle fatigue initiation mechanism in Armco iron. *International Journal of Fatigue*, 2012, 45, pp.91-97. 10.1016/j.ijfatigue.2012.06.005 . hal-01420513

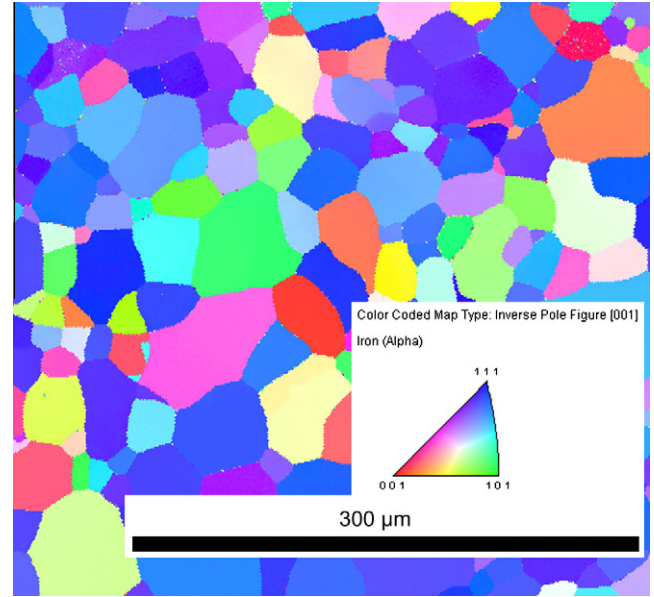
Fig. 1. metallographic orientation.

Investigations carried out on Armco iron that known as typical b.c.c. metal. The chemical compositions indicate on Table 1 below. Metallographic on Fig. 1 shows a ferrite microstructure with grain size 10–40 μm . It has single phase with the inclusion size less than 1.5 μm . No specific orientation was observed by EBSD graph. UTS is 300 MPa. Yield stress is 240 MPa.

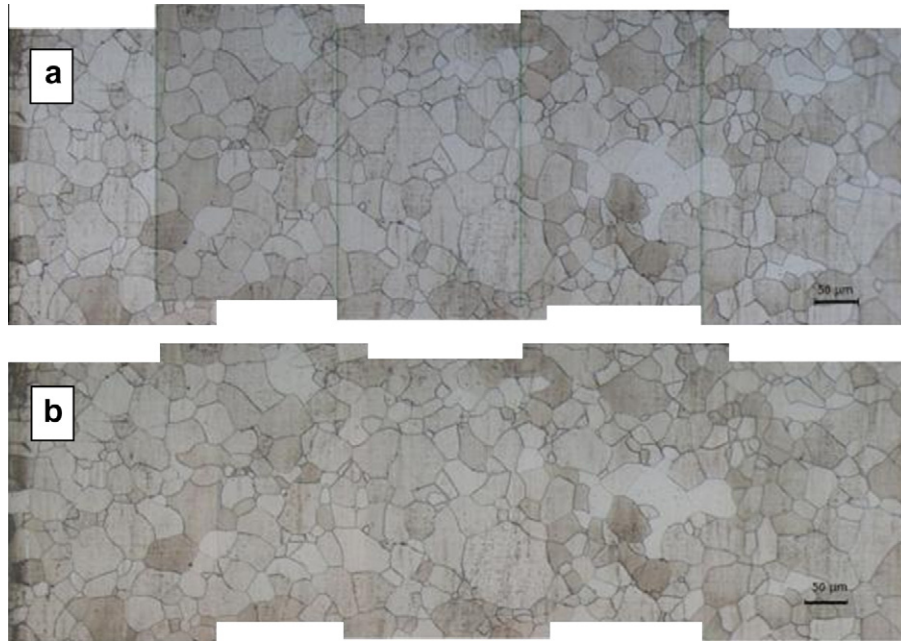
Fig. 9. (a) Before fatigue; (b) micrograph after 5.3×10^9 cycles at 88 MPa.

Specimen tested at low amplitude, fatigue stress $\sigma_a = 88$ MPa after 5.3×10^9 cycles (Fig. 9b), does not show any observable deformation, compared to the optic micrograph in Fig. 9a (initiation state). No localized irreversibility deformation appears on en-

tire area at the low stress after very high cycle loading. However, we cannot conclude that this stress is the fatigue limit. It is only a PSB threshold for a given number of cycles.
