Very High Cycle Fatigue Behavior and Thermographic Analysis of High Strength Steel

Key Words: Very high cycle fatigue, High strength steel, Fish eye, Infrared imaging

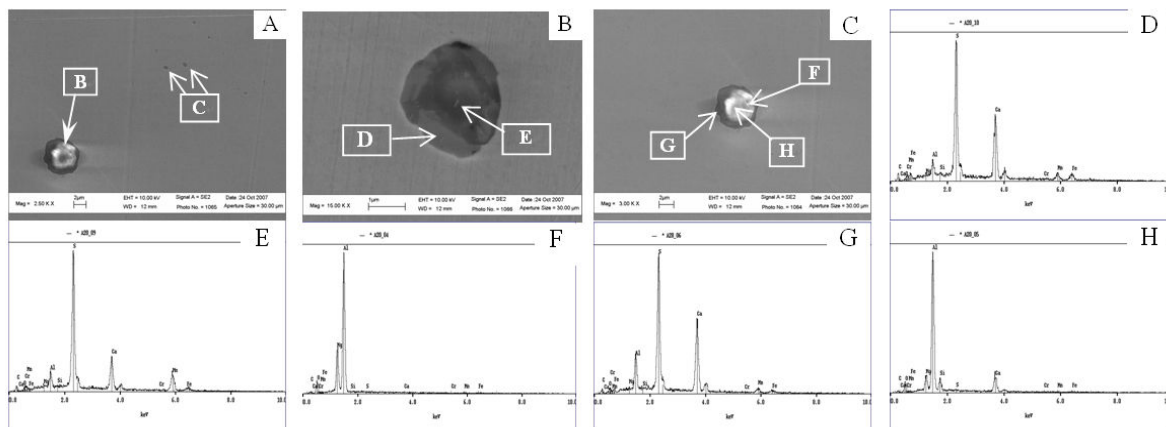
Fig.1 X-ray Analysis of Inclusions

Chemical composition. The steel is a low alloy and ultrahigh strength steel. The microstructure of this steel is martensite with residual austenite. The X-ray analysis of inclusions shows very small MnS inclusions and mixed inclusions (Al, Si, Mg, S, Mn) with larger diameters (Fig 1).

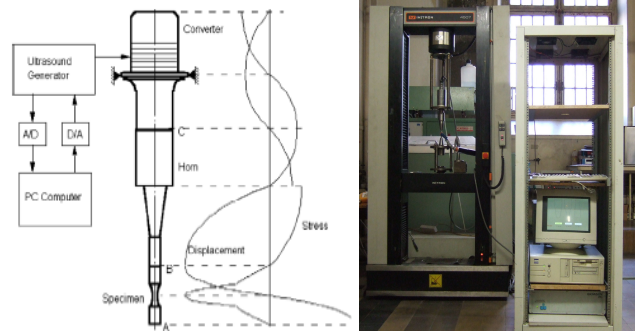
Fig.2 Piezoelectric Fatigue Machine for $R=0.1$ and $R=0.01$

Description of the ultrasonic fatigue test device. Ultrasonic fatigue test machine is composed of power generator, vibration system and control unit. The basic structure and working theory of the machine is that: fatigue vibration system composed of converter, amplifier horn and specimen is a resonance system, the vibration of the resonance system is excited by the generator, the working produce of the system is controlled by control unit.

The vibration system (Fig 2) for cyclic loading consists of a converter, amplifier and the specimen, under the excitation of a system of ultrasonic resonance. The amplifier and the specimen must have a length of resonance of 20 kHz.

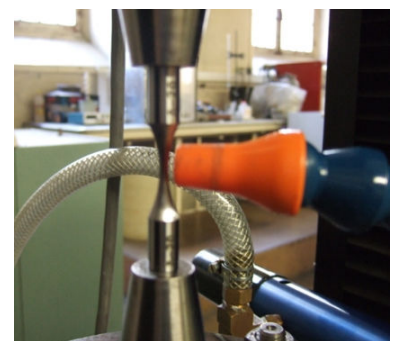
Figure 3. Specimen in the Machine and the Cooling Nozzle

Performed tests. In this work, the test was carried out with a stress ratio $R=0.01$ and $R=0.1$ at several load levels. Compressed air like means of cooling of the specimens has been used to avoid an increase of the temperature (Fig 3).

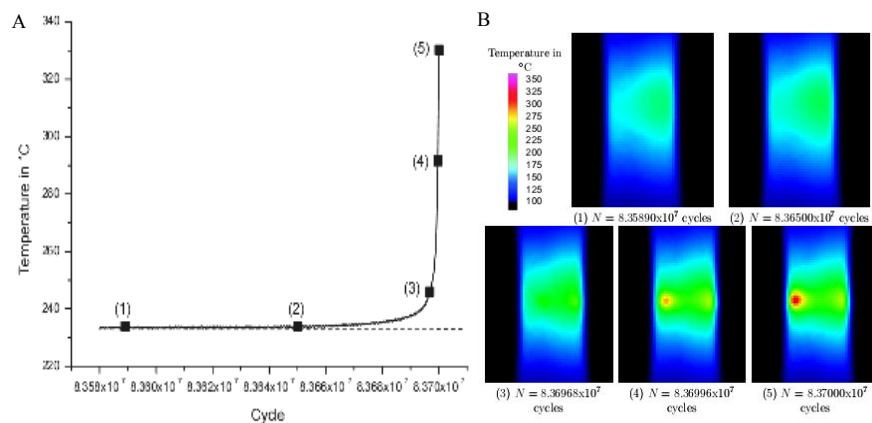
Fig.7 A) Temperature Evolution of the Specimen Surface just before Fracture, B) Temperature Fields on the Specimen Surface just before the Fracture ($\Delta\sigma = 335\text{MPa}$, $N = 8.37 \times 10^7$ cycles)

The test was conducted with amplitude of forced to 335MPa. During this test the rupture occurred after 8.37×10^7 cycles. Fig 7 shows the evolution of the maximum temperature at the surface of the specimen at the time of the rupture. There is then a dramatic rise of the temperature just before the break. The thermo-graphics of Fig 7B shows the temperature fields on the surface of the specimen at different moments represented in Fig 7A just before the break. It was found that the temperature is highly heterogeneous and that the temperature increase is much localized.

The number of cycles at the initiation N_i of fracture is given by point (1). It is 8.3589×10^7 cycles, whereas the number of cycles at fracture N_f is 8.37×10^7 cycles. The ratio N_i over N_f is 0.9987, that means 99.87% (for $N > 10^7$) of the total life is devoted to the initiation of the fracture.

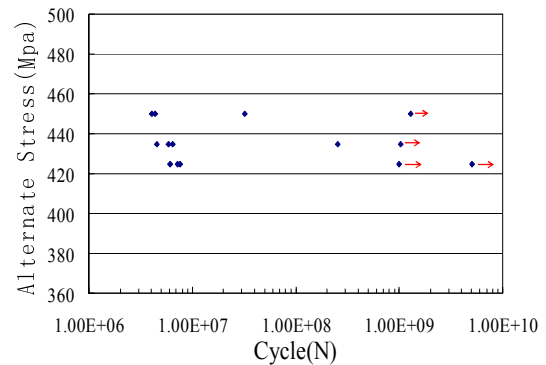
Fig.5 SN curve for $R=0.01$

Mechanical results. The results of the tests in ultrasonic fatigue tests are shown in Fig 5 and 6.

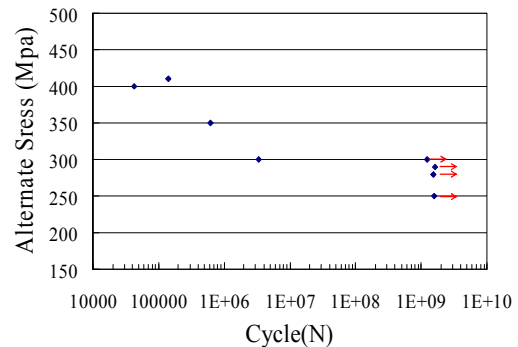
Fig. 6 SN curve for $R=0.1$

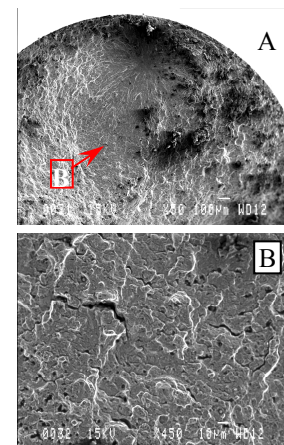
Fig.8 Fractography of Specimen $N_f = 3.19 \times 10^7$, $R=0.1$, Fish eye

Observation of the fracture surface shows a typical mechanism of initiation. Below 5×10^6 cycles, the initiation of the crack is at the surface of the specimen. Beyond 5×10^6 cycles, the initiation is at the interior (Fig 8 and Fig 9). In this case, initiation is related to inclusion size. The direction of the red arrow in the fractography is the initiation of fatigue crack.

The specimen A30 used for thermal recording, the initiation is an inclusion located beneath the surface (Fig.10A), X-ray analysis (Fig.10B) shows that it is mixed inclusions (the larger inclusion) which are responsible of initiation. In the fish eye we can see striation (Fig.8A) and around fish eye, secondary cracks (Fig.9B).

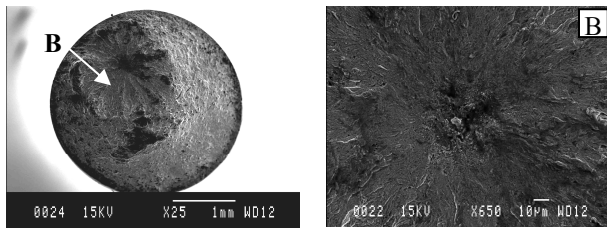
Fig. 9 Fractography of Specimen - $N_f=2.53E+08$, $R=0.1$, Fish Eye

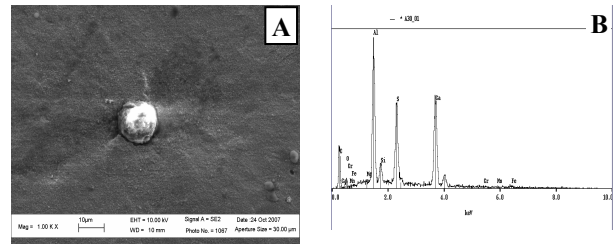
Fig. 10 A) An inclusion of specimen located beneath the surface, B) X-ray of the inclusion of Specimen
