## Surface crack initiation mechanism for body centered cubic materials in the gigacycle fatigue domain

Danièle Wagner, C. Wang, Z. Huang, Claude Bathias

Danièle Wagner, C. Wang, Z. Huang, Claude Bathias. Surface crack initiation mechanism for body centered cubic materials in the gigacycle fatigue domain. *International Journal of Fatigue*, 2016, 93 Part 2, pp.292-300. 10.1016/j.ijfatigue.2016.05.036 . hal-01687219

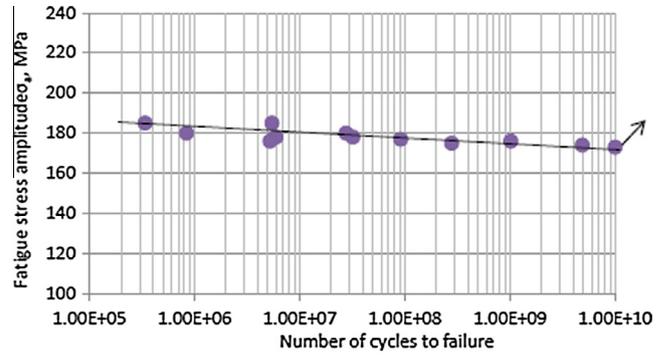
Fig. 1. S/N curve for Armco iron.

The S/N curve is shown in Fig. 1 and was obtained under condition of specimen cooling by a system located at the end of the horn. The specimen temperature (45–65  $^\circ\text{C}$ ) was dependent on the loading amplitude.

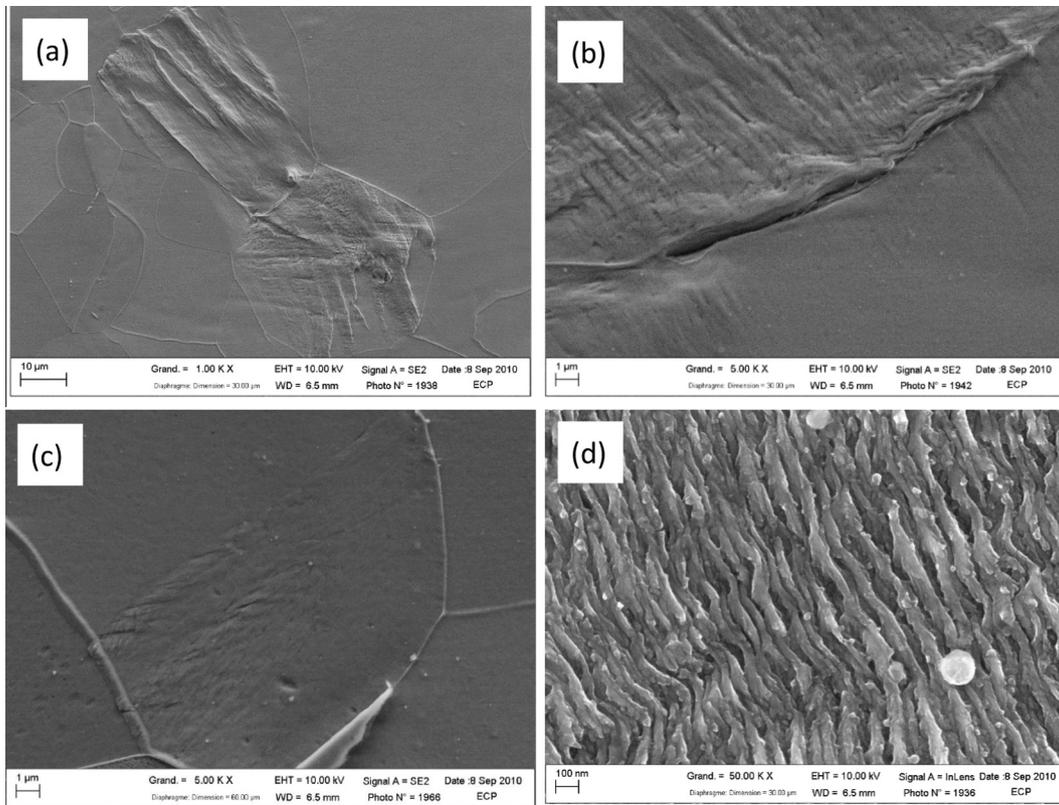
Fig. 2. Appearance of PSBs as observed via SEM.

Detailed observations of surface irreversible PSBs under via SEM are given in Fig. 2. The roughnesses of the PSBs are more or less pronounced depending on the crystallographic orientation of the grain (compare Fig. 2a, b, c). Sometimes a crack would appear in the grain boundary (Fig. 2b). Fig. 2d provides details of intrusions/extrusions which appeared on the surface grain and which had a mean width of 60 nm

cyclic slip irreversibility *p*. The effect of the slip planes asymmetry leads to incompatible shape changes of neighboring grains which provoke intergranular cracking”. The effect of the slip plane asymmetry which leads to incompatible shape changes of neighboring grains is responsible for the microcracks seen in the grain boundary, Fig. 2b.

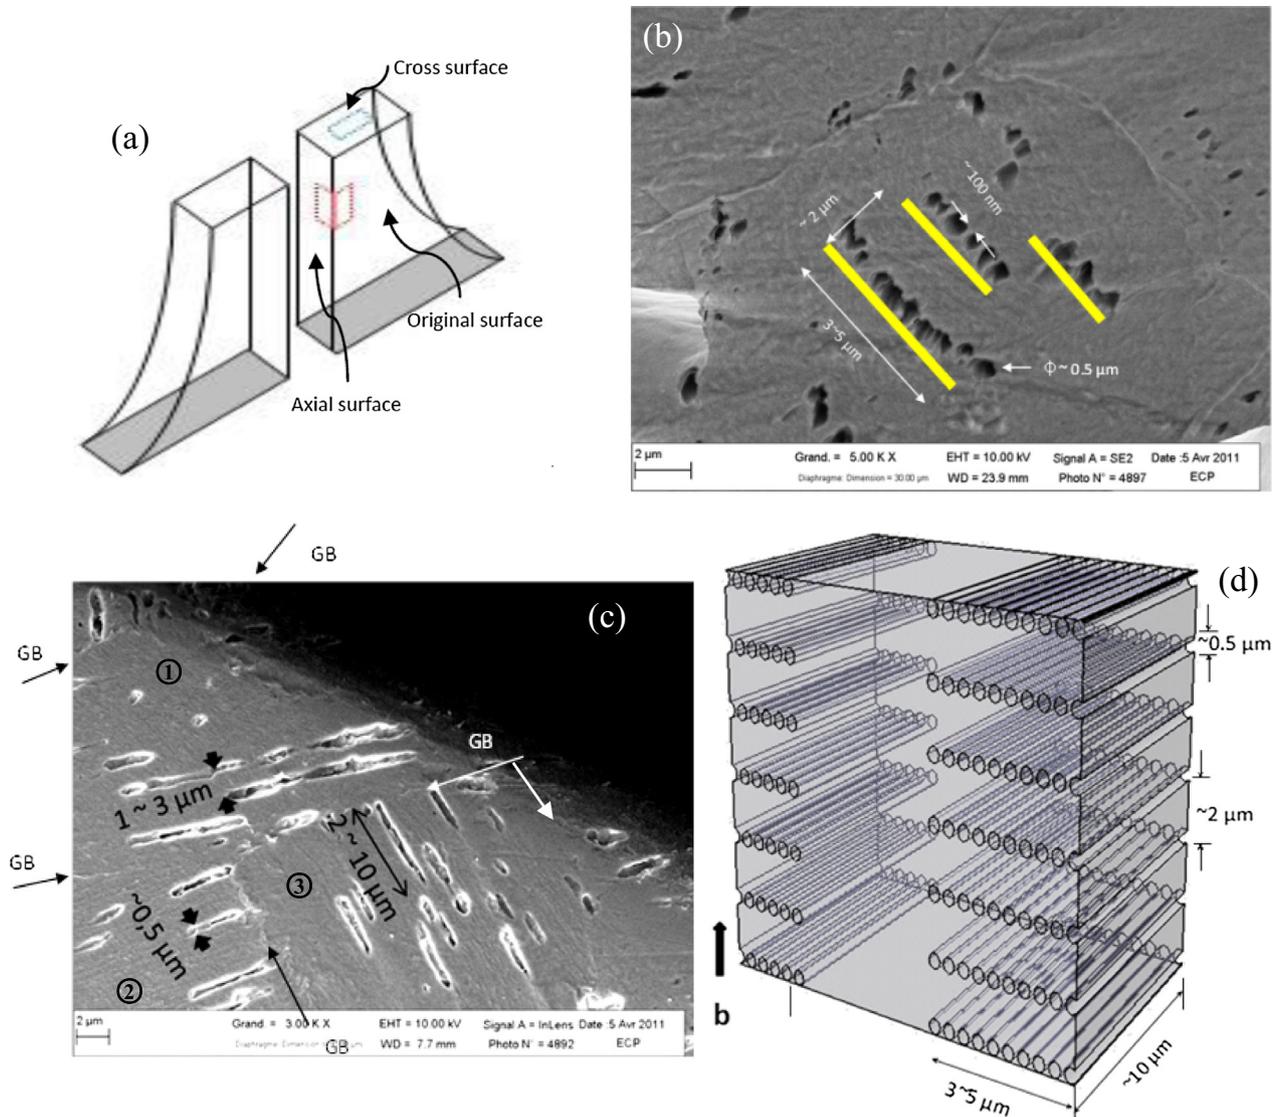
**Fig. 3.** Observed damage just beneath the surface and schematic model of this damage. (a) shows the planes on which observations were made while (b) and (c) are SEM micrographs of defects observed on the cross sectional and axial surfaces respectively. (d) is a proposed schematic of the 3D defect structure.

A specimen showing pronounced PSBs on three perpendicular surfaces, Fig. 3a, was investigated by SEM to gain a 3D understanding of mechanism of PSB formation [21]. The axial and cross surfaces were mechanically polished and etched with 4% Nital.

On the cross section, Fig. 3b, in one grain, equiaxed voids separated (or not) by a thin wall of matrix material (at the nanoscale) were observed. The voids were linearly distributed as shown by the yellow<sup>1</sup> lines. The voids were equiaxed and were about 0.5 μm in diameter. The linear dimension of the void rows was about 3 to 5 μm. The distance between void lines was approximately 2 μm. This feature looks similar to the “bamboo structure” described by Klesnil and Lukas [23]. Observation on the axial cutting surface, Fig. 3c, revealed longitudinal pronounced slots which were parallel in a given grain. A change in the orientation of the slots of about 90° took place at a grain boundary. It seems reasonable to relate those slots to PSB formation on the original specimen surface. It was found that the slots were shallow. It seems these slots are like cylinders. The width of each individual slot is around 0.5 μm, the distance between parallel slots varied from 1 μm to 3 μm and the slot length is between 2 μm and 10 μm. A 3D schematic figure of

the slots (pipes) and voids was developed using this information as shown in Fig. 3d. A presumed Burgers vector is also shown. This model could be used to illustrate the structure of the irreversible slip bands within one grain. The mechanism of forming this 3D structure is related to the gliding of dislocations. According to the grain orientation, the formation of extrusions/intrusions occurs on the specimen surface, Fig. 2a, in some cases. The TEM observations of Klesnil and Lukas [23] on thin foils taken just beneath the surface (1 to 2 μm) clearly show a dislocation structure with bands corresponding to the SM observed on the surface. These bands show regions which have both high and low dislocation densities. In BCC materials, the Transmission Electron Microscope (TEM) observations of the PSB structure do not show the classical wall/ladder structure seen in FCC materials. Never-the-less, with cycling, the strain localizes in narrow bands containing a dislocation cell structure while the matrix structure become quite similar to the vein structure in FCC metals. However, one case of PSBs with the ladder structure in the interior of a fatigued low-carbon steel has been reported ([24] cited by Mughrabi [25]). The PSB ladders revealed by the TEM micrograph are shown in Fig. 4. In the veins and in the walls, the local dislocation density is very high; these appear as black clusters. The distance between two walls in Fig. 4 is about 1.5 μm and is in good agreement

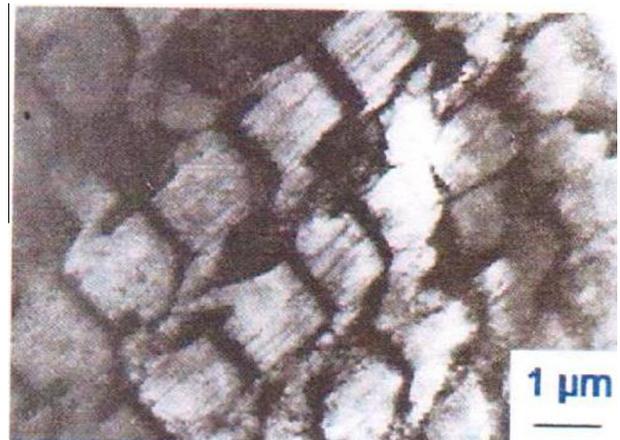
**Fig. 4.** TEM micrograph showing PSB ladders. After [24], cited by [25].

with the distance between longitudinal slots in the 3D model (2 μm). The wall thickness in Fig. 4 is about 0.3 μm and is in good agreement with the width of each individual slot (0.5 μm). The longitudinal

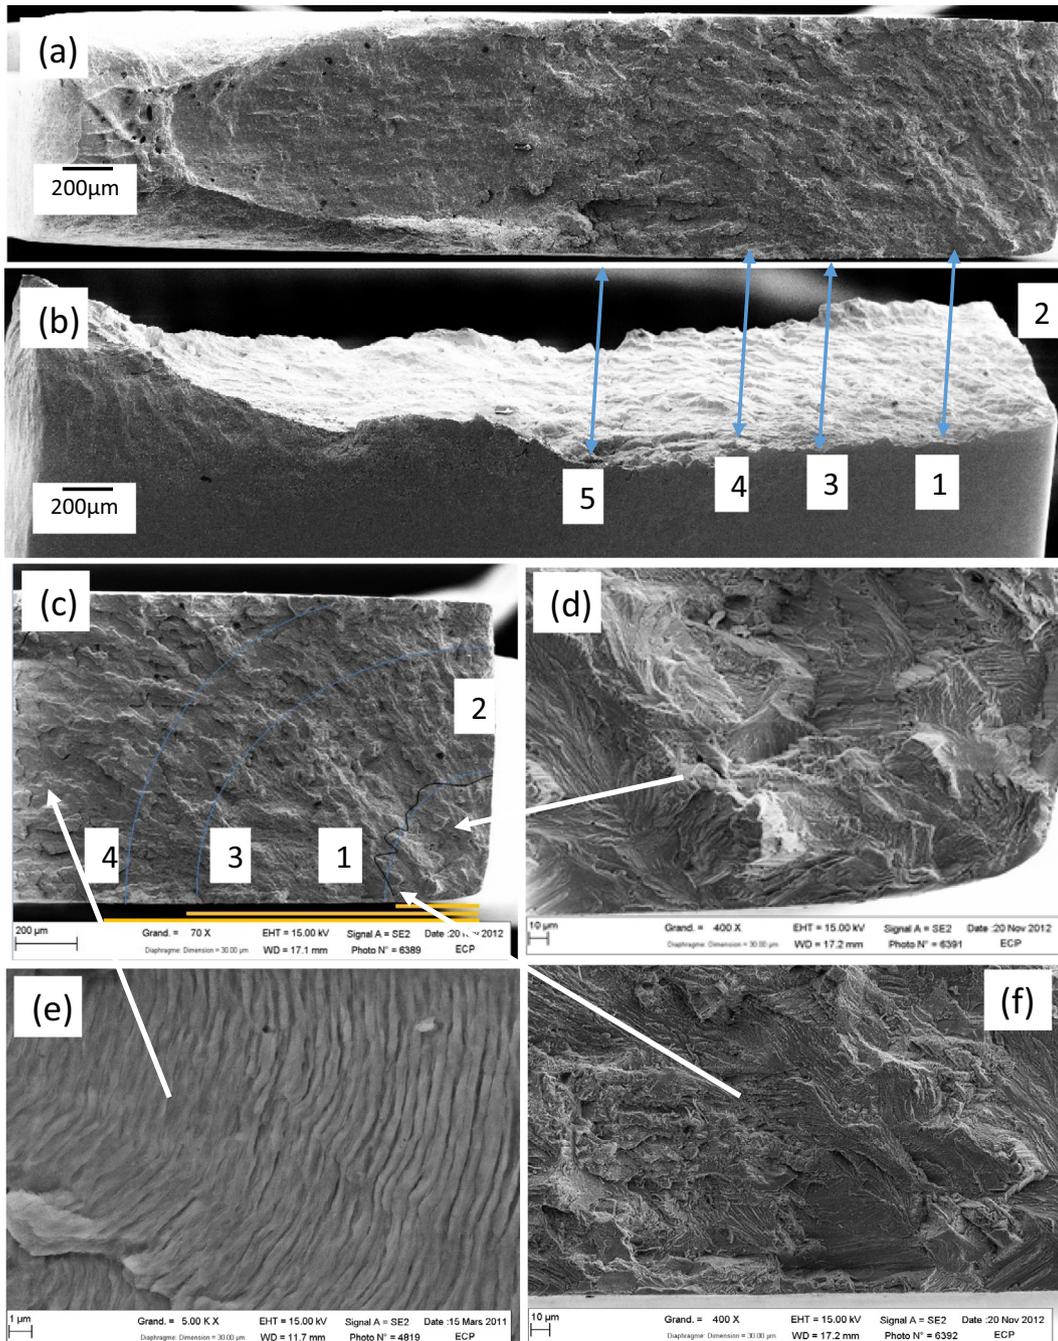
**Fig. 5.** SEM observations of the fracture surface of a specimen tested at  $\sigma_a = 178$  MPa and  $N_f = 3.255 \times 10^7$  cycles. (a) and (b) show two different overviews of the fracture surface while (c) and (d) were taken from the lower part of the specimen and are at higher magnification. Details are discussed in the text.

The fracture surface and the polished specimen surface on which the temperature was recorded were examined via SEM. Fig. 5a and b shows the fracture surface of the specimen tested at  $\sigma_a = 178$  MPa and  $N_f = 3.255 \times 10^7$  cycles. Note that for all tests, the observations were qualitatively similar. Up to point 5, the fracture surface was flat and corresponding to plane strain fatigue cracking.

Enlargement of the plane strain region, Fig. 5c, shows two main zones separated by the line at the point 3. After point 3, stage II of long crack propagation began with striations (Fig. 5e). At the beginning of stage II, the striations were not well established, whereas after point 3 (and the corresponding line), the striations were well defined. The mating surface of the specimen was examined and results are shown in Fig. 5c and d. On the right side of Fig. 5c, the crack initiation site is located in the lower edge and the grain traces are clearly observed, Fig. 5d, whereas after the point 1, Fig. 5c, the fracture surface appearance changes (Fig. 5f). Those changes are attributed to the transition from the crack initiation stage (stage I) to a transition zone.

On Fig. 5c, consistent with all the SEM observations, the transition between stage 1 and the transition crack propagation zone on the fracture surface is shown. For the Armco iron tested on flat specimens, the crack initiation site was located either at a corner,

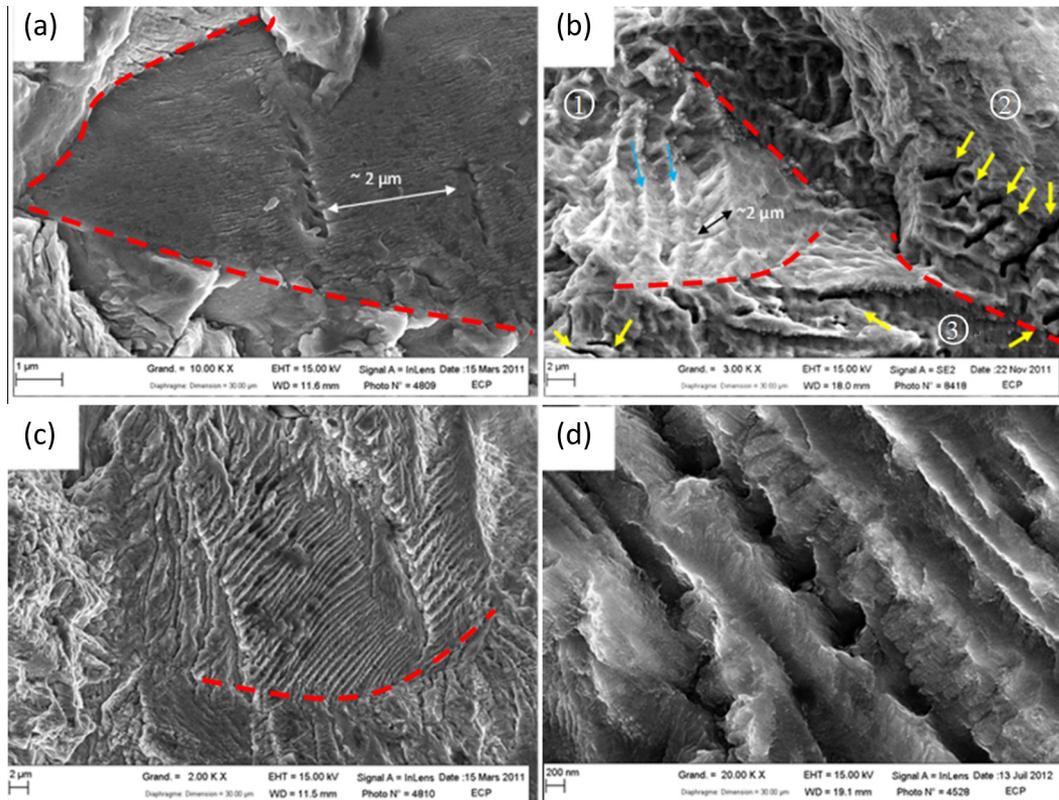
Fig. 6. SEM observations of the crack initiation stage. Details of the crack initiation surface: (a) shows intergranular crack, (b) a mixed crack, (c) and (d) a transgranular crack.

In the initiation area, three types of patterns were found: (1) intergranular, (2) transgranular and (3) mixed. The intergranular pattern is seen in Fig. 6a. This intergranular crack surface appears not smooth, but presents a very fine linear structure on the grain surface which is believed to be related to slip planes intersection with the fracture surface. Moreover, two rows of voids about 2 μm distant are visible. The type of mixed transgranular/intergranular crack surface is shown in Fig. 6b in an area of grain

intersections such as triple points. Mixed transgranular/intergranular fracture surface through grain 1 is present as a staircase (blue arrows) in Fig. 6b. The distance between two steps is about 2 μm. The yellow arrows on the middle right side of Fig. 6b indicate patterns similar to those found in Fig. 6a in the intergranularly cracked grain. A transgranular crack surface is shown in Fig. 6c. In this case, the fracture surface is composed of longitudinal slots arranged side by side. The diameter of the slots is 0.5 μm in average. A mechanistic approach at the crack initiation stage was provided based on the fracture surface pattern and the 3D model of Fig. 3d is suggested. An illustration of this fracture mechanism is

schematically shown in Fig. 7. The staircase structure shown in Fig. 6b, is probably a fracture occurring partially on the pipes, and crossing over the pipes just below. The distance between two steps is about  $2\ \mu\text{m}$  which is in good agreement with the distance between two planes of the pipes. In the case of the transgranular pattern Fig. 6c, the crack path is entirely going through the pipes in the same slip plane. The characteristic dimension of a pipe diameter is about  $0.5\ \mu\text{m}$ . The line of hollows (separated by a distance of about  $2\ \mu\text{m}$ ) present on the intergranular crack as in Fig. 6a and on the cross section as in Fig. 6d are probably the end of pipes at grain boundary (in good agreement with the distance between two neighbored pipe planes).

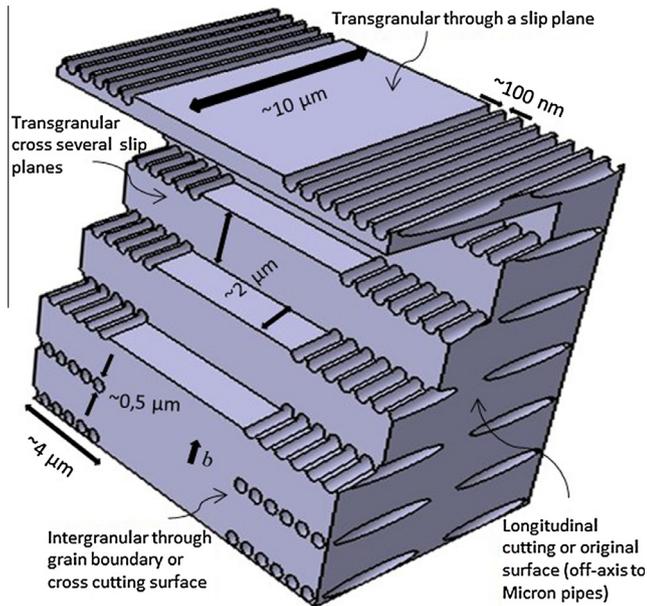
Fig. 7. Schematic model for the crack initiation stage.

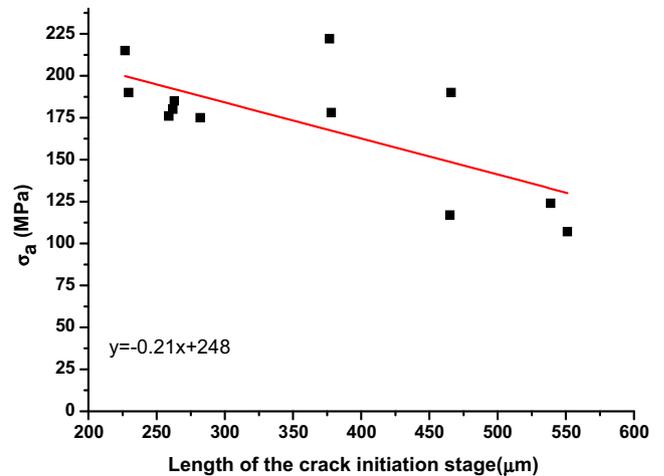
Fig. 8. Evolution of the crack initiation stage length with the stress amplitude. The line was obtained from a least squares fit.

the fatigue limit. In the LCF range, it varies from 0.1 to 1  $\mu\text{m}$  [6,28]. In the test reported above in the VHCF domain, the crack initiation stage involved about 10 grains and measured about 300  $\mu\text{m}$ . The formula for the stress intensity factor, is a function of the applied stress, the crack size, and the geometry. Typically, when  $\sigma_a$  decreases, the crack length at the end of the initiation stage must increase to keep  $\Delta K_{\text{transition}}$  constant. Here, in the VHCF domain, where  $\sigma_a$  decreases from 200 to 100 MPa, the crack length at the end of the initiation stage goes from 200 to 550  $\mu\text{m}$  in the Armco iron, Fig. 8.

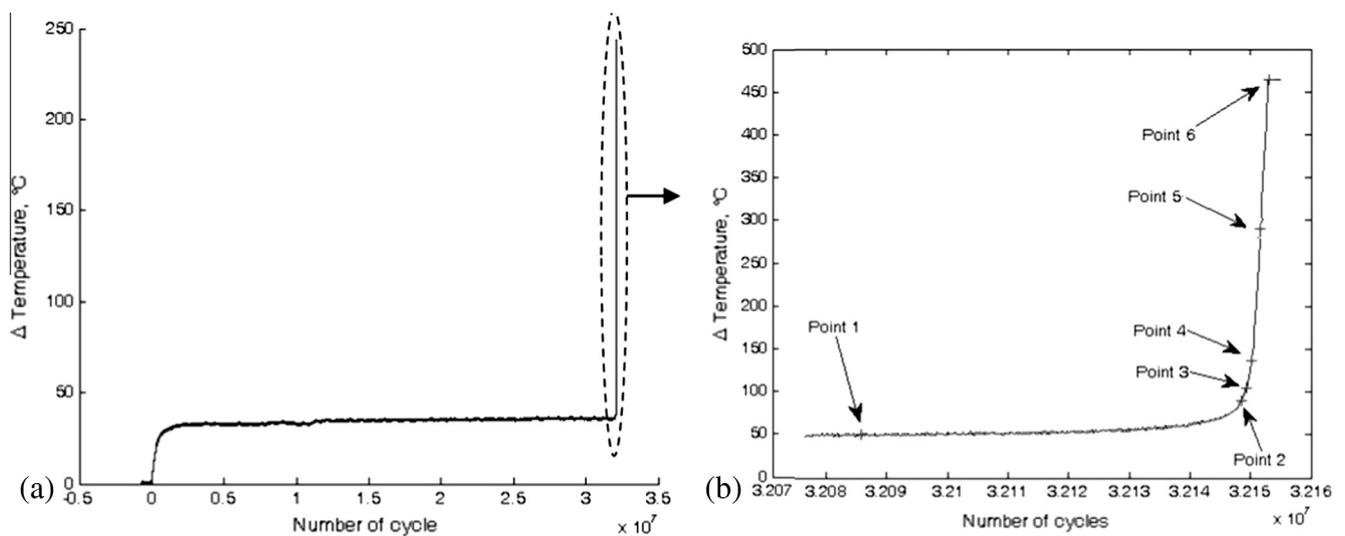
Fig. 9. Evolution of the temperature recording on the specimen surface at different locations during a fatigue test. (b) shows the cycle scale expanded to bring out details (see text).

The specimen surface temperature is shown in Fig. 9a and b (which is an enlargement of the end of Fig. 9a). It corresponds to  $\sigma_a = 175$  MPa and  $N_f = 3.21 \times 10^7$  cycles. From these data, the temperature profile across the specimen width was taken from the last

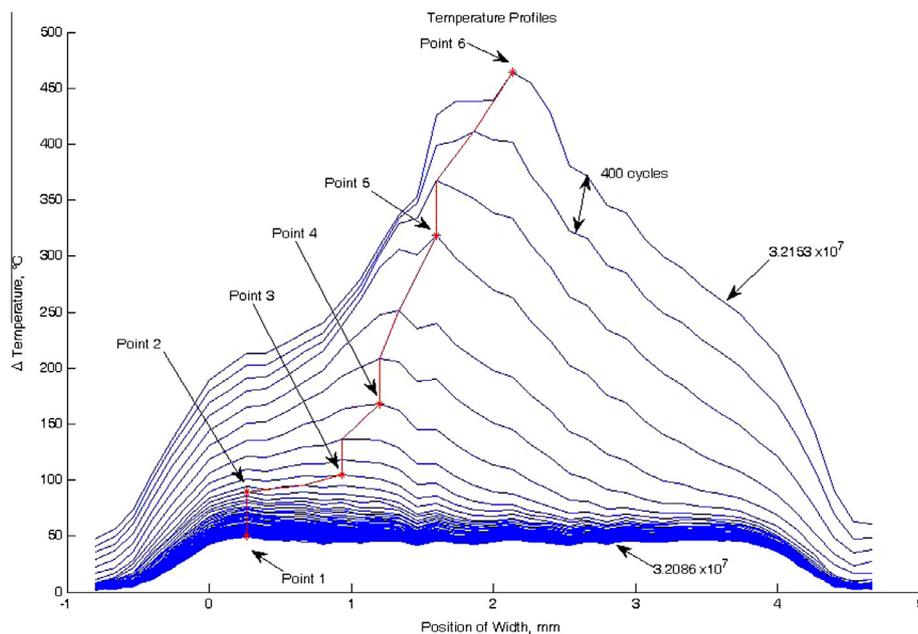
Fig. 10. Temperature profile along the specimen width.

168 frames captured by the IR camera before fracture (Fig. 10). The red line (Fig. 10) is the location where the temperature is maximum along the profile. The location where the temperature reaches its highest point along the profile, moves from the initiation stage (in the corner) to the final fracture. The IR camera resolution is such that the location of the crack tip at different times can be determined by the maximum temperature location. The study shows six points where the temperature had changed significantly. The corresponding number of cycles of these six points is reported in Fig. 9b. Each location where there is a large temperature change can be compared with the fractographic observations in Fig. 5c. The yellow lines in these figures are the locations of the points where the temperature maximum has an obvious inflection. Location 1 correspond to the end of the crack initiation stage on the side where the temperature field is recorded. After the occurrence of point 1, the temperature does not change until it reaches point 2 as seen in Fig. 10. Probably, this time is consumed to coalesce the damage due to PSB between the specimen sides from point 1 to 2, (Fig. 5c).

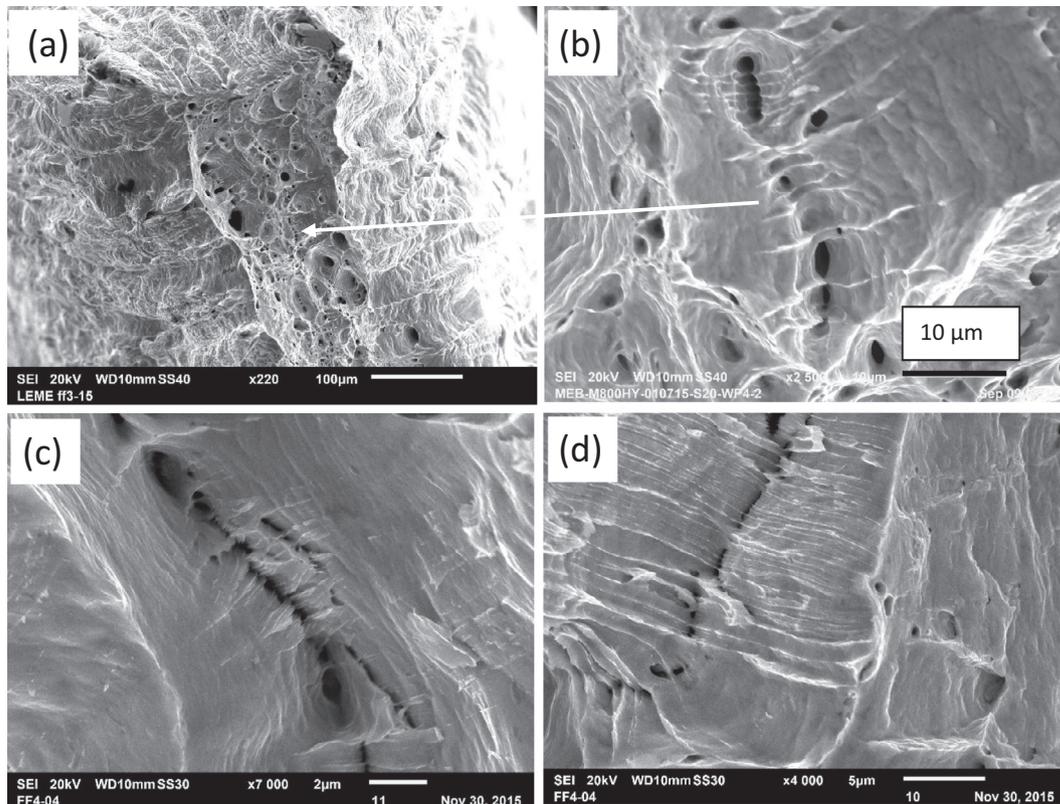
**Fig. 11.** Fracture surface observations of interrupted fatigue specimens fractured under monotonic tensile loading. ((a), (b): specimen FF3-15, (c), (d): specimen FF4-04).

evident, Fig. 11. Fig. 11a shows part of the fracture surface at low magnification. Due to the reduction of area during tensile test, the specimen thickness is much reduced. On the side of the specimens slip bands were seen. On some grains on the fracture surface, (Fig. 11b) circular contiguous holes appear. On specimen FF4-04, where the cooling system was switched off for about 1 h, the damage process is more pronounced, and near these holes a transgranular fracture surface is visible similar to that shown in Fig. 6c. These features appear to be the first damage in the specimen. In Fig. 11c, 2 lines of the end pipes (as in Fig. 3b) are visible. Due to the reduction of area, it is difficult to rigorously compare the characteristic lengths, but the sizes are of the same order of magnitude as discussed previously. The first damage appears as the occurrence of pipes (empty walls) in the matrix. For these thin specimens, the subsurface damage seen in the bulk specimen substantiates the thermal assumptions. Between points 1 and 2, Fig. 9b, the initiation stage starts and is due to the coalescence of all accumulated damage. Probably damage begins very early as the occurrence of PSBs on the specimen surface during fatigue tests.
