Surface crack initiation mechanism for body centered cubic materials in the gigacycle fatigue domain

Danièle Wagner, C. Wang, Z. Huang, Claude Bathias

Danièle Wagner, C. Wang, Z. Huang, Claude Bathias. Surface crack initiation mechanism for body centered cubic materials in the gigacycle fatigue domain. *International Journal of Fatigue*, 2016, 93 Part 2, pp.292-300. 10.1016/j.ijfatigue.2016.05.036 . hal-01687219

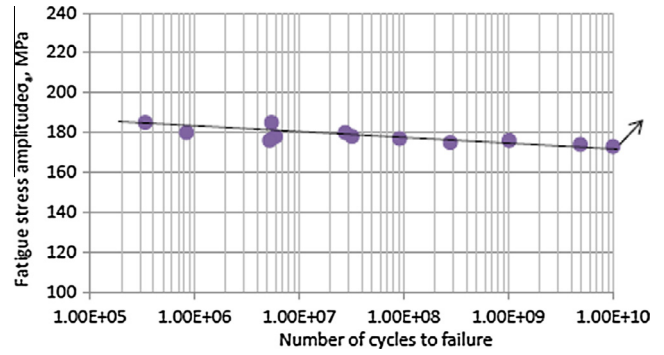
Fig. 1. S/N curve for Armco iron.

The S/N curve is shown in Fig. 1 and was obtained under condition of specimen cooling by a system located at the end of the horn. The specimen temperature (45–65 $^\circ\text{C}$) was dependent on the loading amplitude.

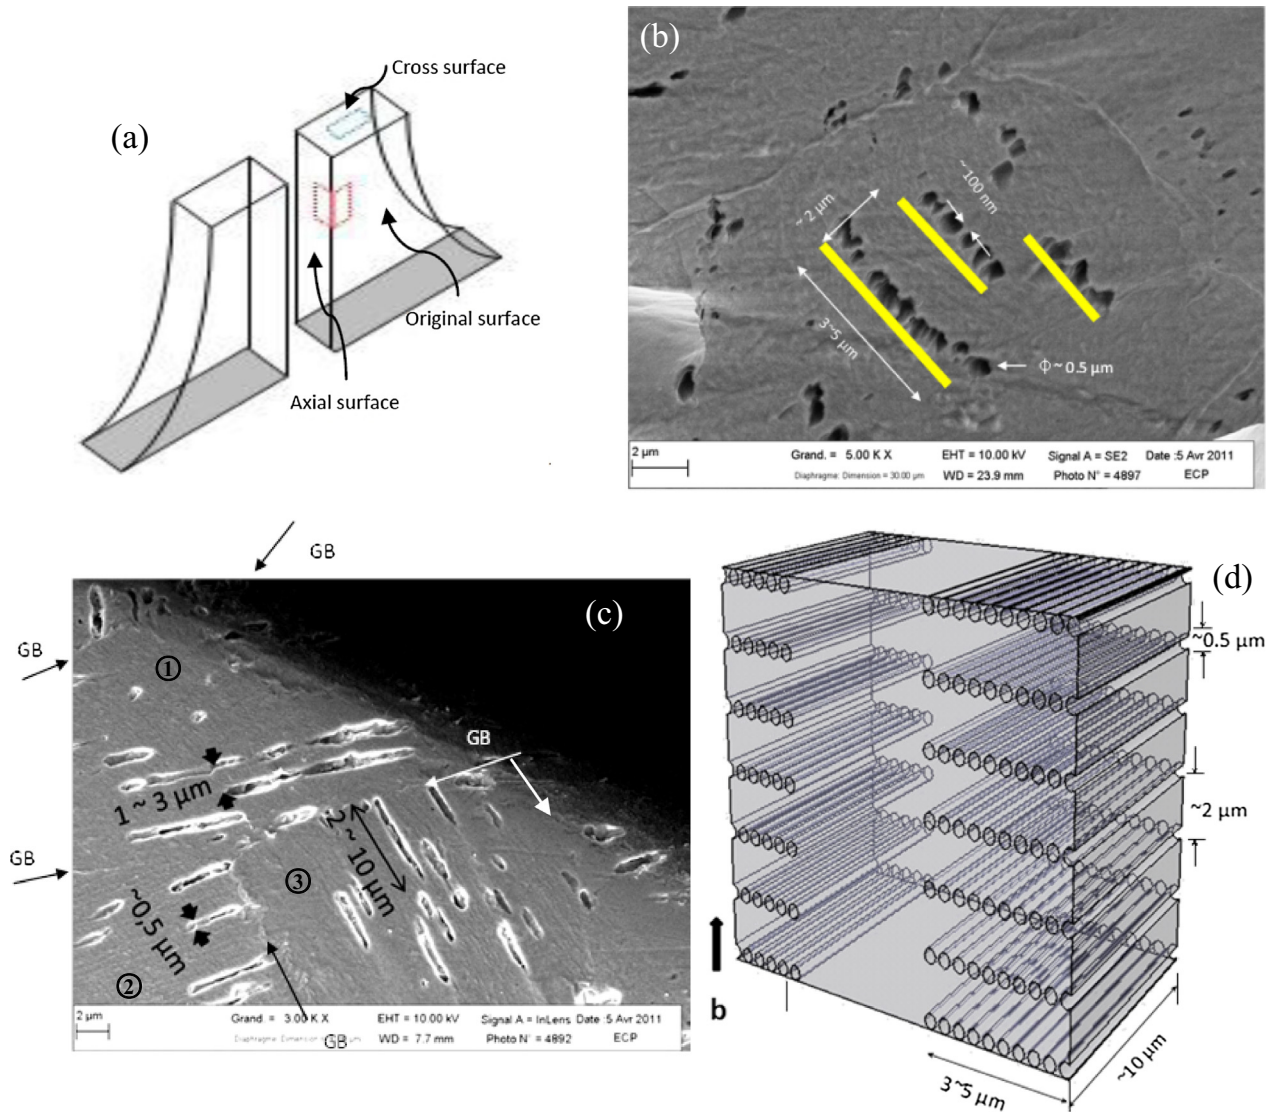
Fig. 3. Observed damage just beneath the surface and schematic model of this damage. (a) shows the planes on which observations were made while (b) and (c) are SEM micrographs of defects observed on the cross sectional and axial surfaces respectively. (d) is a proposed schematic of the 3D defect structure.

A specimen showing pronounced PSBs on three perpendicular surfaces, Fig. 3a, was investigated by SEM to gain a 3D understanding of mechanism of PSB formation [21]. The axial and cross surfaces were mechanically polished and etched with 4% Nital.

On the cross section, Fig. 3b, in one grain, equiaxed voids separated (or not) by a thin wall of matrix material (at the nanoscale) were observed. The voids were linearly distributed as shown by the yellow¹ lines. The voids were equiaxed and were about 0.5 μ m in diameter. The linear dimension of the void rows was about 3 to 5 μ m. The distance between void lines was approximately 2 μ m. This feature looks similar to the “bamboo structure” described by Klesnil and Lukas [23]. Observation on the axial cutting surface, Fig. 3c, revealed longitudinal pronounced slots which were parallel in a given grain. A change in the orientation of the slots of about 90° took place at a grain boundary. It seems reasonable to relate those slots to PSB formation on the original specimen surface. It was found that the slots were shallow. It seems these slots are like cylinders. The width of each individual slot is around 0.5 μ m, the distance between parallel slots varied from 1 μ m to 3 μ m and the slot length is between 2 μ m and 10 μ m. A 3D schematic figure of

the slots (pipes) and voids was developed using this information as shown in Fig. 3d. A presumed Burgers vector is also shown. This model could be used to illustrate the structure of the irreversible slip bands within one grain. The mechanism of forming this 3D structure is related to the gliding of dislocations. According to the grain orientation, the formation of extrusions/intrusions occurs on the specimen surface, Fig. 2a, in some cases. The TEM observations of Klesnil and Lukas [23] on thin foils taken just beneath the surface (1 to 2 μm) clearly show a dislocation structure with bands corresponding to the SM observed on the surface. These bands show regions which have both high and low dislocation densities. In BCC materials, the Transmission Electron Microscope (TEM) observations of the PSB structure do not show the classical wall/ladder structure seen in FCC materials. Never-the-less, with cycling, the strain localizes in narrow bands containing a dislocation cell structure while the matrix structure become quite similar to the vein structure in FCC metals. However, one case of PSBs with the ladder structure in the interior of a fatigued low-carbon steel has been reported ([24] cited by Mughrabi [25]). The PSB ladders revealed by the TEM micrograph are shown in Fig. 4. In the veins and in the walls, the local dislocation density is very high; these appear as black clusters. The distance between two walls in Fig. 4 is about 1.5 μm and is in good agreement

intersections such as triple points. Mixed transgranular/intergranular fracture surface through grain 1 is present as a staircase (blue arrows) in Fig. 6b. The distance between two steps is about 2 μm. The yellow arrows on the middle right side of Fig. 6b indicate patterns similar to those found in Fig. 6a in the intergranularly cracked grain. A transgranular crack surface is shown in Fig. 6c. In this case, the fracture surface is composed of longitudinal slots arranged side by side. The diameter of the slots is 0.5 μm in average. A mechanistic approach at the crack initiation stage was provided based on the fracture surface pattern and the 3D model of Fig. 3d is suggested. An illustration of this fracture mechanism is

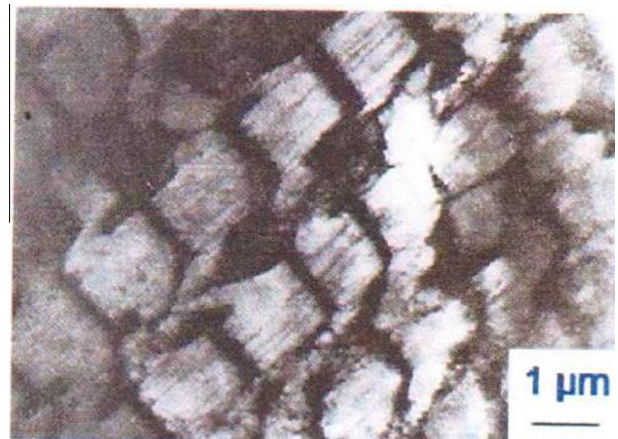
Fig. 4. TEM micrograph showing PSB ladders. After [24], cited by [25].

with the distance between longitudinal slots in the 3D model (2 μm). The wall thickness in Fig. 4 is about 0.3 μm and is in good agreement with the width of each individual slot (0.5 μm). The longitudinal

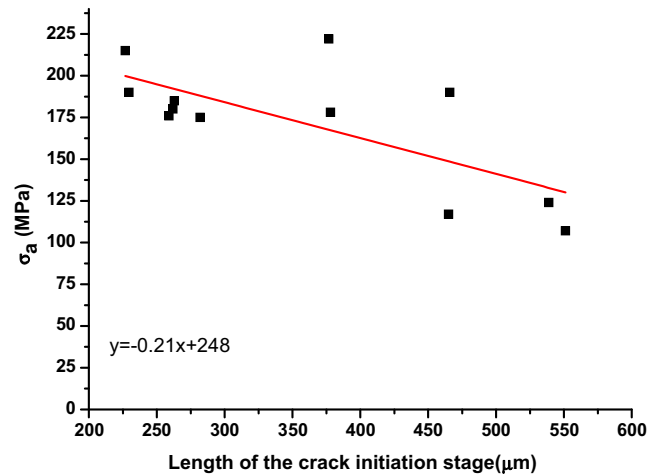
Fig. 8. Evolution of the crack initiation stage length with the stress amplitude. The line was obtained from a least squares fit.

the fatigue limit. In the LCF range, it varies from 0.1 to 1 μm [6,28]. In the test reported above in the VHCF domain, the crack initiation stage involved about 10 grains and measured about 300 μm . The formula for the stress intensity factor, is a function of the applied stress, the crack size, and the geometry. Typically, when σ_a decreases, the crack length at the end of the initiation stage must increase to keep $\Delta K_{\text{transition}}$ constant. Here, in the VHCF domain, where σ_a decreases from 200 to 100 MPa, the crack length at the end of the initiation stage goes from 200 to 550 μm in the Armco iron, Fig. 8.

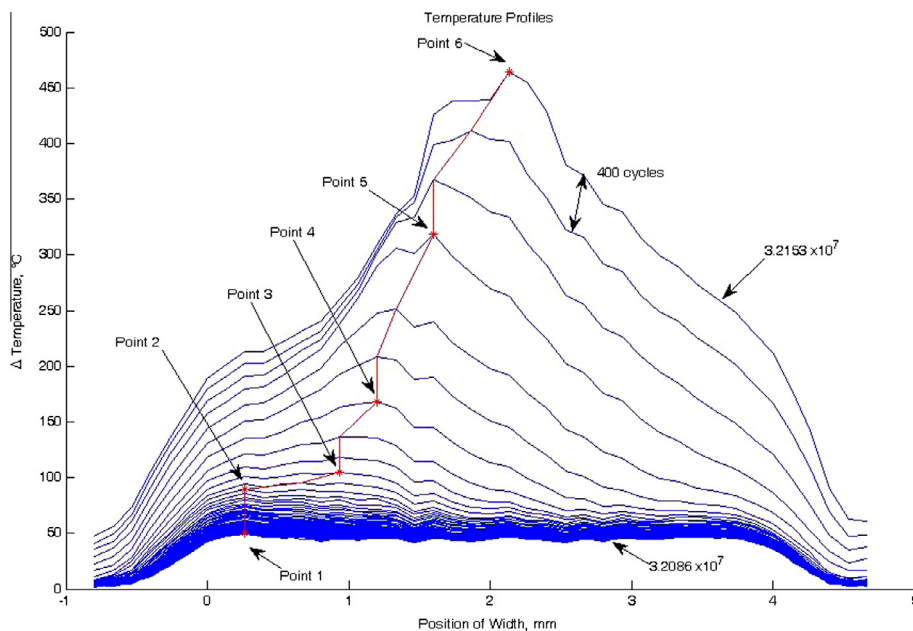
Fig. 10. Temperature profile along the specimen width.

168 frames captured by the IR camera before fracture (Fig. 10). The red line (Fig. 10) is the location where the temperature is maximum along the profile. The location where the temperature reaches its highest point along the profile, moves from the initiation stage (in the corner) to the final fracture. The IR camera resolution is such that the location of the crack tip at different times can be determined by the maximum temperature location. The study shows six points where the temperature had changed significantly. The corresponding number of cycles of these six points is reported in Fig. 9b. Each location where there is a large temperature change can be compared with the fractographic observations in Fig. 5c. The yellow lines in these figures are the locations of the points where the temperature maximum has an obvious inflection. Location 1 correspond to the end of the crack initiation stage on the side where the temperature field is recorded. After the occurrence of point 1, the temperature does not change until it reaches point 2 as seen in Fig. 10. Probably, this time is consumed to coalesce the damage due to PSB between the specimen sides from point 1 to 2, (Fig. 5c).
