Thermal phenomenon of glass fibre composite under tensile static and fatigue loading

Jefri Bale, Emmanuel Valot, Olivier Polit, Claude Bathias, Martine Monin, Tresna Soemardi

Jefri Bale, Emmanuel Valot, Olivier Polit, Claude Bathias, Martine Monin, et al.. Thermal phenomenon of glass fibre composite under tensile static and fatigue loading. *Journal of Mechanical Engineering and Sciences*, 2017, 11 (2), pp.2755-2769. 10.15282/jmes.11.2.2017.16.0250 . hal-04382019

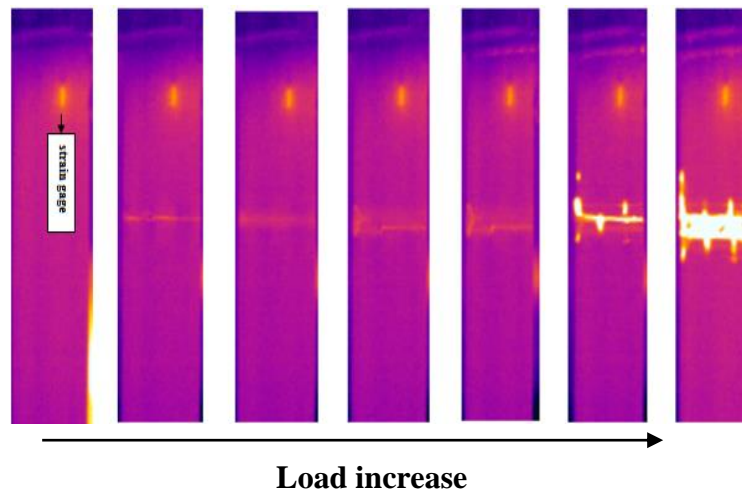
Figure 3. Thermal images of GFRP composite without hole.

During the test, specimen surface was also observed by the IR camera to follow the evolution of temperature. Figure 3 shows the thermal images up to the final failure. In order to follow the evolution of temperature during the test, the area profile was used at several areas of specimen surface to study all changes of the maximum temperature until the final failure, as seen in Figure 4.

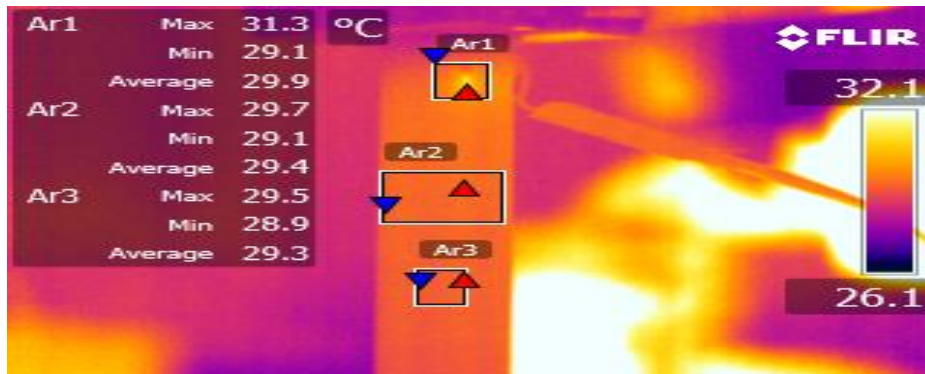
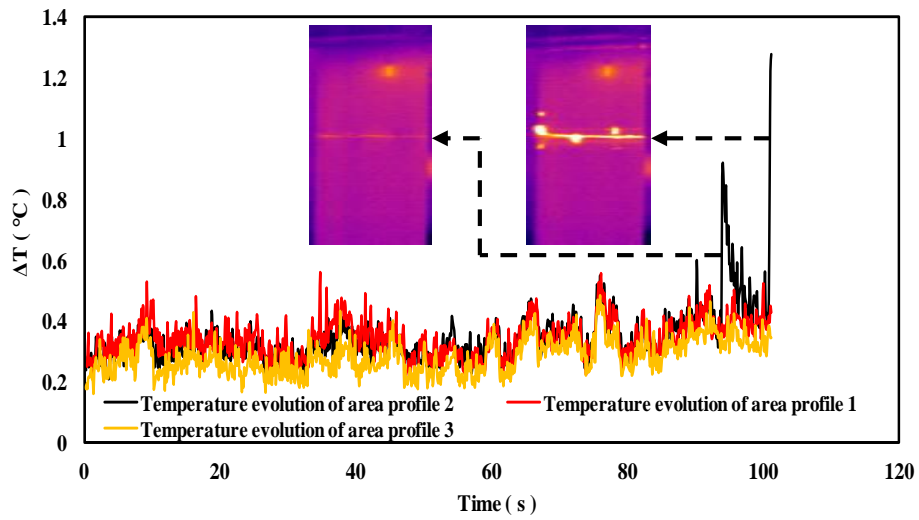
Figure 4. Temperature evolution of GFRP composite without hole.

From Figure 4 above, all the temperature surfaces (ΔT) detected by the IR camera varied between $0.2 - 1.3$ °C. From the comparison between thermal images and temperature change during the test before the final failure, ΔT above 0.6 °C was clearly shown by several peaks of temperature profile related to the presence of macro damage. When damage occurred, it represented the energy which was gradually released. The energy that has been absorbed was sufficient to create macro-cracks, enlarging the pre-existent ones, and also to create new inner and surface cracks. The heat generated from

a) Temperature image observation / profile area

b) Before final failure

c) Until final failure

Each of the peak of temperature indicated different types of initial macro damage. We found that $\Delta T \approx 0.9 \text{ }^\circ\text{C}$ was directly associated with the appearance of macro matrix cracking and $\Delta T \approx 1.3 \text{ }^\circ\text{C}$ was related with the appearance of interfacial failure or splitting. The higher temperature of splitting was in fact due to absorbing more energy of damage [48]. From the temperature evolution during the tensile test, the presence of macro damage indicated the area of final failure which was concentrated in the region of the failure area. In sum, the initial macro damage provoked the occurrence of catastrophic or final failure of the specimen that induced the highest peak of temperature at $\Delta T \approx 37 \text{ }^\circ\text{C}$.

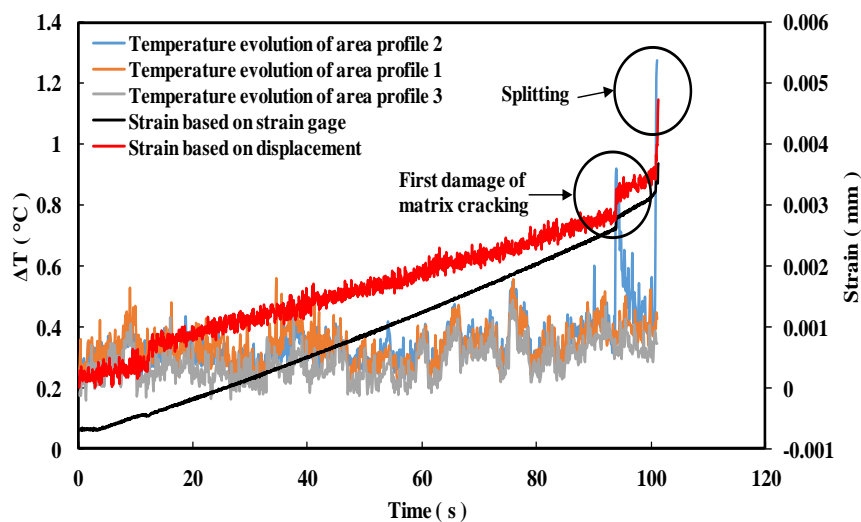
Figure 5. Strain and temperature evolution of GFRP composite without hole

Using the information of strain propagation that occurred when this initial macro damage occurred, thermography and strain gage confirmed the presence of initial macro damage which happened before the catastrophic or final failure of the specimen as seen in Figure 5. The damage appearances were shown with a small discontinuity in the strain curve and also higher increase of temperature at the same time. It can be noted that the combination of this experimental method of thermography observation by IR camera and strain propagation by strain gage under static tensile loading can give good local information and excellent correlation with local strain from the strain gage about the early damage appearance and propagation, as well as damage type and damage location until a rupture based on the temperature profile and strain value of GFRP composite [42].

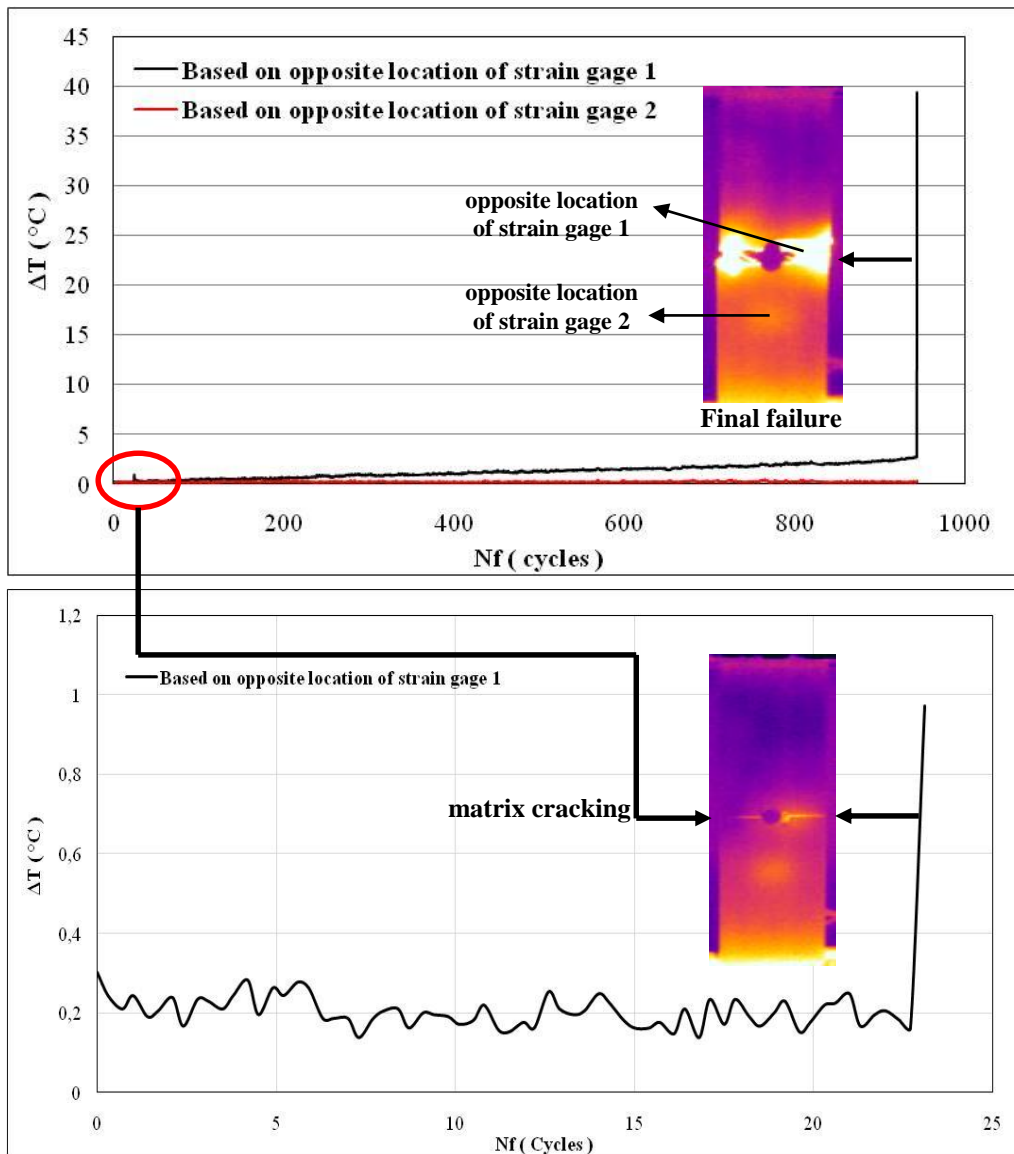
Figure 6. Evolution of surface temperature of GFRP composite.

During the fatigue tests, IR camera was used to follow the temperature changes on the specimen surface. Figure 6 represents the temperature changes at the edge of the hole during the fatigue test with 65% of UTS. From Figure 6, all the temperature surface (ΔT) detected by IR camera varied between $0.2 - 39 \text{ }^\circ\text{C}$. From the comparison between thermal images and temperature change during the test before the final failure, $\Delta T \approx 0.9 \text{ }^\circ\text{C}$ which was clearly shown by the peak of temperature profile related to the presence of the first macro damage of matrix cracking. After that, the temperature was shown to reach a stable period of the increase trend [37]. The temperature profile had a gradual increase trend with the slope $\approx 0.001 \text{ }^\circ\text{C}/\text{cycle}$ until around 200 cycles and continued to increase with a slightly higher slope $\approx 0.002 \text{ }^\circ\text{C}/\text{cycle}$. The temperature increased until around 800 cycles. The trend of temperature experienced a significant increase at the final period.

With three times of higher slope, at $0.006\text{ }^{\circ}\text{C}/\text{cycle}$ until reaching the rupture, ΔT suddenly increased and reached the highest $\Delta T \approx 39\text{ }^{\circ}\text{C}$ at one cycle. The temperature evolution was then compared with the damage evolution as seen in Figure 7. From the temperature and damage evolution during the tensile fatigue test (Figure 6 and Figure 7), the presence of damage was indicated by temperature change on the specimen surface during the test that existed and concentrated at the hole. Meanwhile, the temperature evolution at other areas of specimen surface that were far from the hole did not show an increase of temperature or relative to have the same temperature from the beginning of the test until the rupture of the specimen [47]. When damage occurred, it represented the energy which was gradually released. The heat generated from the energy release was then detected by the IR camera that showed an increase in temperature in the area of damage. The evolution of the temperature can be categorised in four stages. In the first part, the initial increase of temperature was possibly due to the micro cracking in matrix [47]. In the second part, a sudden increase in temperature was caused by the first

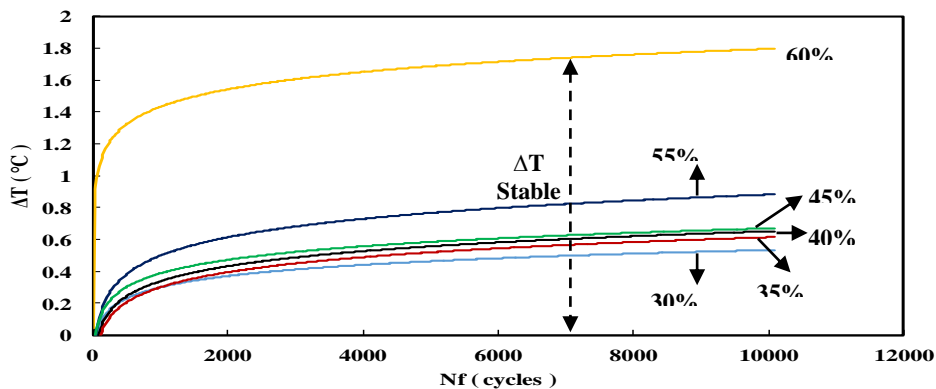
Figure 8. Temperature profile of GFRP composite for each load level.

The purpose of this analysis is to determine the fatigue strength based on experimental results by means of IR camera and energy dissipated in a unit volume of material. Thermographic approach that relies on the use of an IR camera, as originally called the Risitano method has shown to be useful for the determination of high cycle fatigue strength (HCFS) of composite material [34, 48, 49]. The main advantage of this method provides a rapid determination of HCFS that is a very efficient time-consuming procedure and provides substantial saving of fatigue test costs [49-51]. This test was conducted using GFRP composite with a holed specimen and under the loading frequency of 3Hz and $R = 0.1$. Using the IR camera, a temperature profile for specimen surface was used as a function of the number of cycles for a test with different load levels. The fatigue tests were conducted until 10000 cycles to have a stable or a plateau profile of temperature evolution as is seen in Figure 8.

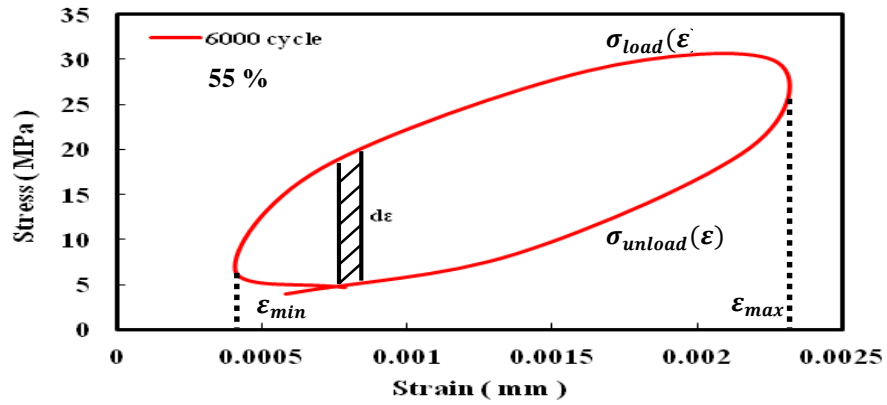
Figure 10. Hysteresis loop and energy dissipation for GFRP composite.

Figure 9 confirms the HCFS of 53 % of UTS, and it can be noted that HCFS was determined by the thermography approach successfully applied for the GFRP composite material. Furthermore, an investigation for a quantitative characterisation based on intrinsic energy dissipation was presented to validate the accuracy of the thermography approach. The energy dissipation was identified as the area enclosed by a hysteresis loop for a particular cycle according to the cycle in the ΔT_{stable} period, as illustrated in Figure 10(a). Next, a plot of energy dissipation per unit volume as a function of the load was created to determine HCFS as seen in Figure 10(b).

The HCFS of $\approx 48\%$ of UTS obtained by energy dissipation in Figure 10 was found to not differ significantly to that obtained using the thermography method in Figure 9. From the comparison result of HCFS based on thermography and HCFS based on energy dissipation, the thermography method showed good correlation of following the damage behaviour with the conventional approach, which is a key finding to study the damage behaviour of unidirectional GFRP composite. Furthermore, a plot in Figure 11 was established between energy dissipation per unit volume and ΔT_{stable} for each load level of fatigue test to obtain the relationship between thermal dissipated detected by IR camera and energy dissipated from the hysteresis heating. The relation between stabilisation temperature profile and the energy dissipation during fatigue test can be approximated by a linear function with a data correlation factor, R^2 close to 1. It can be said that the increasing of temperature detected by the IR camera on the specimen surface as a result of thermal dissipated was in fact due to energy dissipation of the material. The

a. Hysteresis loop during 55% of UTS

b. Energy dissipation as a function of load level
