Thermal phenomenon of glass fibre composite under tensile static and fatigue loading

Jefri Bale, Emmanuel Valot, Olivier Polit, Claude Bathias, Martine Monin, Tresna Soemardi

Jefri Bale, Emmanuel Valot, Olivier Polit, Claude Bathias, Martine Monin, et al.. Thermal phenomenon of glass fibre composite under tensile static and fatigue loading. *Journal of Mechanical Engineering and Sciences*, 2017, 11 (2), pp.2755-2769. 10.15282/jmes.11.2.2017.16.0250 . hal-04382019

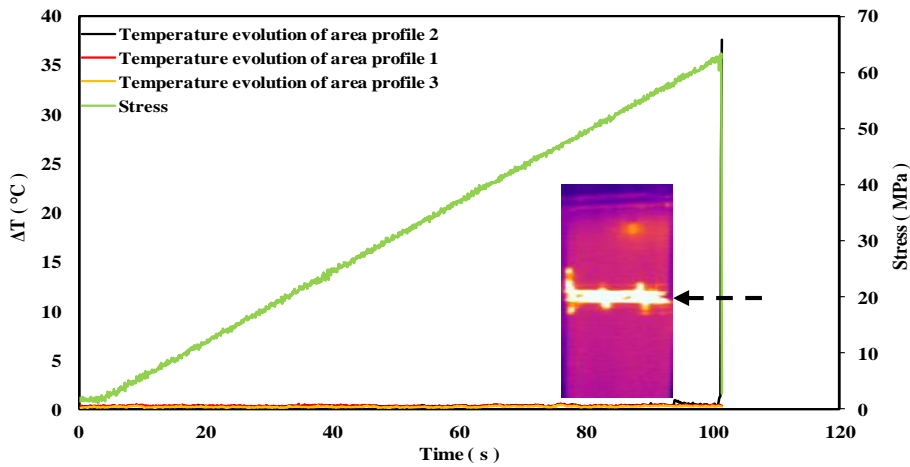
Figure 4. Temperature evolution of GFRP composite without hole.

From Figure 4 above, all the temperature surfaces (ΔT) detected by the IR camera varied between 0.2 – 1.3 °C. From the comparison between thermal images and temperature change during the test before the final failure, ΔT above 0.6 °C was clearly shown by several peaks of temperature profile related to the presence of macro damage. When damage occurred, it represented the energy which was gradually released. The energy that has been absorbed Was sufficient to create macro-cracks, enlarging the pre-existent ones, and also to create new inner and surface cracks. The heat generated from

a) Temperature image observation / profile area

b) Before final failure

c) Until final failure

During the test, specimen surface was also observed by the IR camera to follow the evolution of temperature. Figure 3 shows the thermal images up to the final failure. In order to follow the evolution of temperature during the test, the area profile was used at several areas of specimen surface to study all changes of the maximum temperature until the final failure, as seen in Figure 4.

Each of the peak of temperature indicated different types of initial macro damage. We found that $\Delta T \approx 0.9 \text{ }^\circ\text{C}$ was directly associated with the appearance of macro matrix cracking and $\Delta T \approx 1.3 \text{ }^\circ\text{C}$ was related with the appearance of interfacial failure or splitting. The higher temperature of splitting was in fact due to absorbing more energy of damage [48]. From the temperature evolution during the tensile test, the presence of macro damage indicated the area of final failure which was concentrated in the region of the failure area. In sum, the initial macro damage provoked the occurrence of catastrophic or final failure of the specimen that induced the highest peak of temperature at $\Delta T \approx 37 \text{ }^\circ\text{C}$.

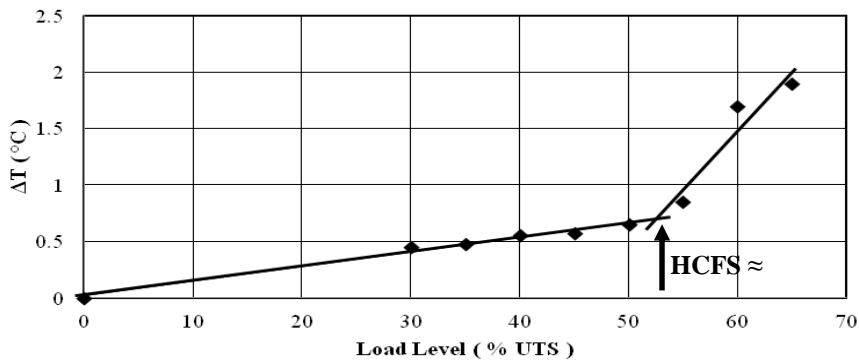
Figure 9. HCFS of GFRP composite by thermography method.

According to the Risitano method, the high cycle fatigue strength of material can be determined from the intersection of temperature profile ΔT_{stable} of different stress levels obtained by separately fitting the experimental data for low and high stress amplitudes on the x -axis, respectively (for stress levels below and above the expected fatigue limit). From Figure 8, after 50% of load level, there was a significant or higher increase of temperature compared to under 50% of load level. This load level was then used to categorise the stress level of below and above, which showed the characteristic of bilinear profile used for this method. Figure 9 shows how the HCFS was determined using a graphical procedure based on the thermography method. It was noted that this method is a true in situ measurement technique. Thermography is a measurement technique which provides the information (image, profile, distribution) of the temperature on the surface of the examined object in real time [36, 37, 49]. The deformation of solid materials is almost always accompanied by releases of heat. When the material becomes deformed or is damaged and fissured, a part of energy is necessary and the propagation of the damage is transformed in an irreversible way into heat [52].

Figure 9 confirms the HCFS of 53 % of UTS, and it can be noted that HCFS was determined by the thermography approach successfully applied for the GFRP composite material. Furthermore, an investigation for a quantitative characterisation based on intrinsic energy dissipation was presented to validate the accuracy of the thermography approach. The energy dissipation was identified as the area enclosed by a hysteresis loop for a particular cycle according to the cycle in the ΔT_{stable} period, as illustrated in Figure 10(a). Next, a plot of energy dissipation per unit volume as a function of the load was created to determine HCFS as seen in Figure 10(b).

The HCFS of $\approx 48\%$ of UTS obtained by energy dissipation in Figure 10 was found to not differ significantly to that obtained using the thermography method in Figure 9. From the comparison result of HCFS based on thermography and HCFS based on energy dissipation, the thermography method showed good correlation of following the damage behaviour with the conventional approach, which is a key finding to study the damage behaviour of unidirectional GFRP composite. Furthermore, a plot in Figure 11 was established between energy dissipation per unit volume and ΔT_{stable} for each load level of fatigue test to obtain the relationship between thermal dissipated detected by IR camera and energy dissipated from the hysteresis heating. The relation between stabilisation temperature profile and the energy dissipation during fatigue test can be approximated by a linear function with a data correlation factor, R^2 close to 1. It can be said that the increasing of temperature detected by the IR camera on the specimen surface as a result of thermal dissipated was in fact due to energy dissipation of the material. The

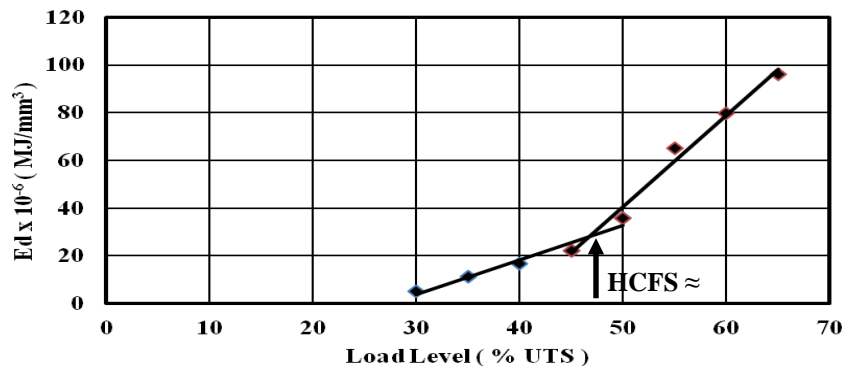
Figure 10. Hysteresis loop and energy dissipation for GFRP composite.

a. Hysteresis loop during 55% of UTS

b. Energy dissipation as a function of load level
